**Phase I Environmental
Site Assessment**

Proposed Milpitas Library Expansion Parcels
Milpitas, California

June 3, 2004

Project No. 692-15

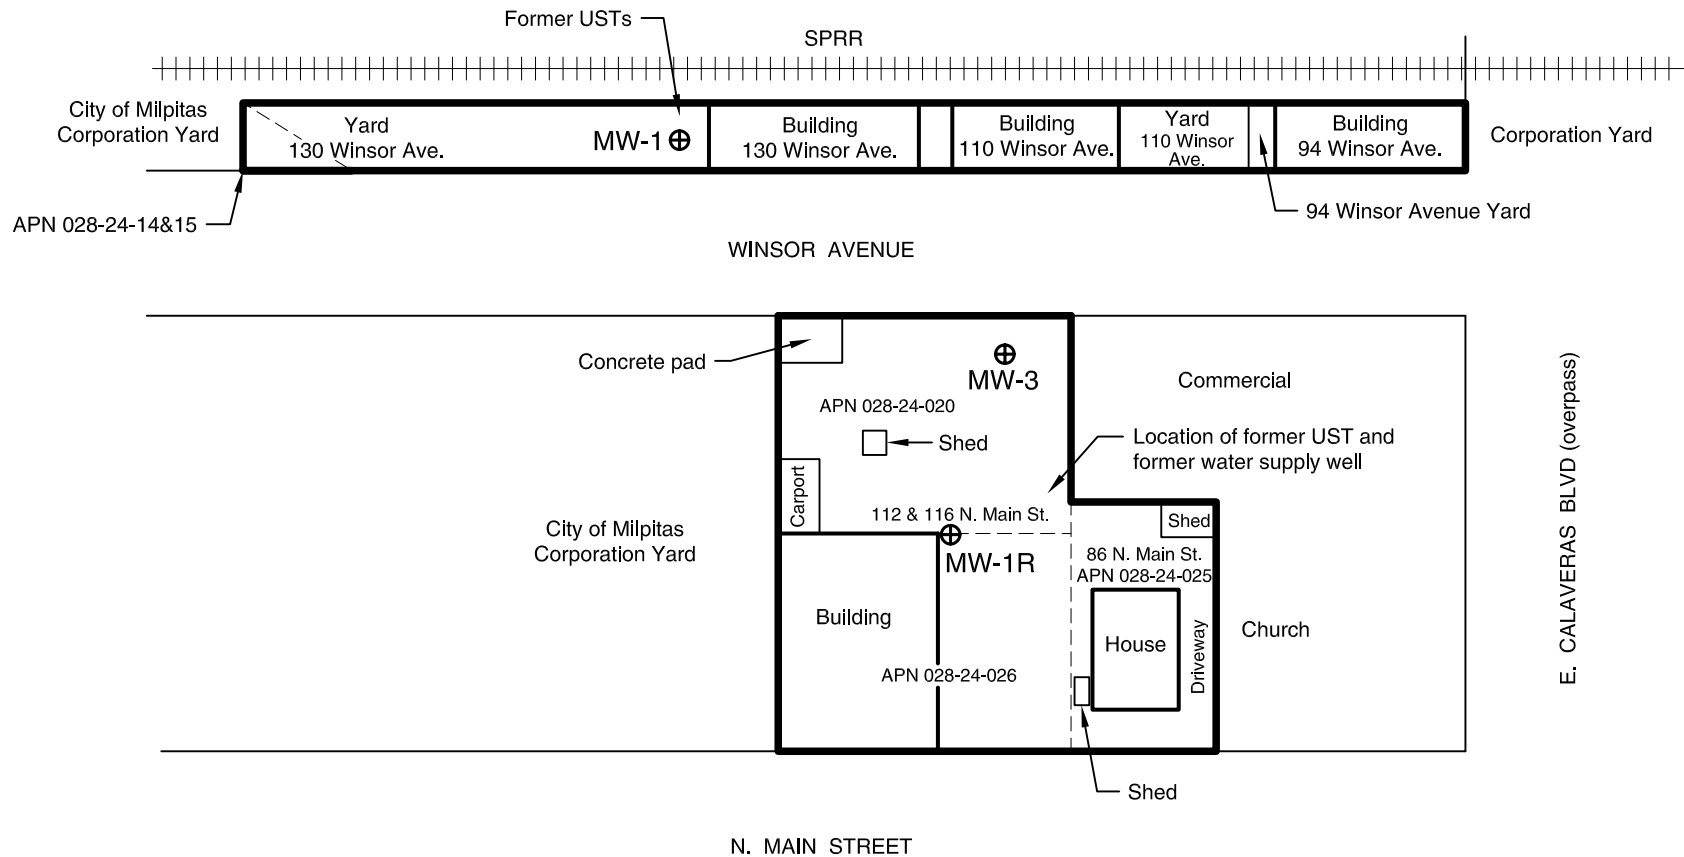
FIGURE 2 — SITE PLAN

One wood-framed structure with a concrete floor was observed along the North Main Street frontage of the 112/116 North Main Street parcels (Figure 2). A water tower (without a water tank) was attached to the structure. According to Mr. Pallack, the building was a historical blacksmith shop and was later used by the City of Milpitas for office and storage purposes. The building was leased to Garbe's Towing, but at the time of our reconnaissance it was being used by Mr. Pallack for storage of assorted items, primarily items reportedly from his personal garage and home. Approximately eight automobiles, a trailer, two boats, several electric forklifts, tires, auto batteries, assorted auto parts and pieces, toys, holiday decorations, lawn mowers, generators, and pallets of forklift batteries were observed within the building. Small quantities (individual bottles of approximately 1 quart to 1 gallon each) of assorted cleaners, paints, and automotive chemicals were observed on the concrete floor and stacked on other materials. Minor staining of the concrete floor was observed, as was moderate corrosion of the concrete floor adjacent to one pallet of forklift batteries. Restrooms were observed on the north side of the building, reportedly added on by the City of Milpitas. Due to water leakage into the restrooms, the walls and ceilings of these rooms were badly damaged and deteriorating.

A carport-type structure with a deteriorated concrete floor was connected to the eastern side of the main structure (Figure 2). Numerous pieces of metal and wood were observed within the structure.

One small metal shed was also present on the parcels (Figure 2). According to Mr. Pallack, the shed was previously used by the City of Milpitas for hazardous materials storage. The shed, located on a concrete slab, was observed to contain numerous tires, other automotive parts, and assorted metal and wood pieces stored by Economy Towing.

Adjacent to the southern side of the 94 Winsor Avenue building was a small fenced storage yard with an asphalt-paved surface (Figure 2). One forklift was observed within the yard.

Adjacent to the southern side of the 110 Winsor Avenue building was a small, fenced storage yard with a deteriorated asphalt paved surface (Figure 2). Two empty poly drums were observed within the yard. According to Mr. Dimmick, these drums previously contained water.
